# Immediate Molar Implant Placement

Managing patient expectations

## CASE REPORT

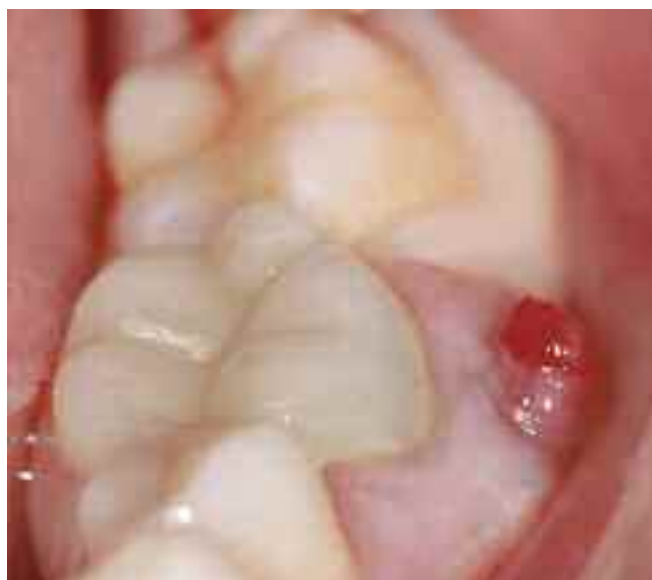
**Figure 1**

Initial clinical appearance of tooth # 36.

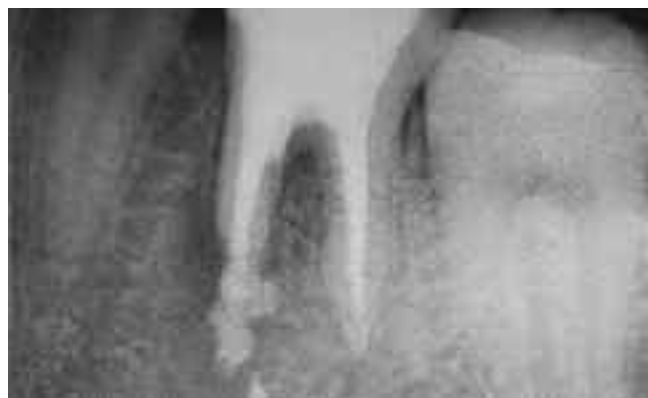
**Figure 2**

Tooth #36 was diagnosed with a hopeless prognosis. It exhibited less than grade one mobility and a buccally draining fistula. The radiograph of #36 showed a periapical bony lesion and frank bone loss (Figure 2). The conventional treatment for this type of case would typically include the following steps: extraction of the tooth, up to three weeks delay for resolution of the infection, surgical re-entry for ridge preservation with particulate bone grafting and collagen membrane placement, a three to six-month healing period, implant placement, an additional three to six-month healing period and final attachment of the prosthesis to the osseointegrated fixture.

Initial radiographic appearance of tooth #36. Note periapical lesion and bone loss.

- extraction of tooth #36; followed by
- immediate implant placement; combined with
- a particulate bone graft as well as plasma rich in growth factors (PRGF).

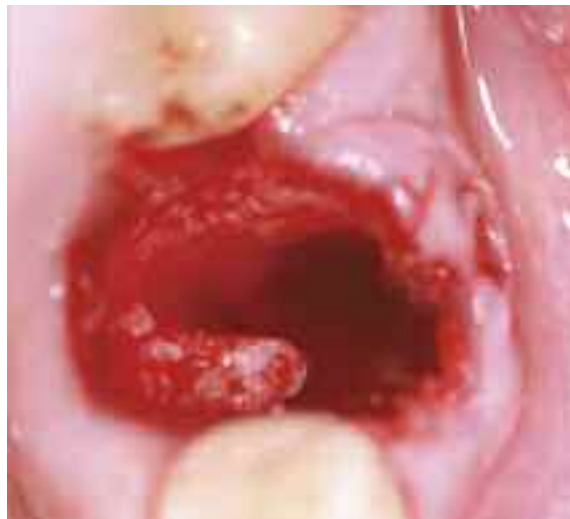
**Figure 3**  
Extraction reveals socket with complete buccal bone loss and large bony deficiency.

Initial treatment involved a forceps extraction of tooth #36 with vigorous curettage of the defect and complete removal of granulation tissue. This revealed an empty socket with complete buccal bone loss and large bony deficiency (Figure 3). In order to be used later as an autograft, the interseptal bone was removed with a ronguer. A five by 12 millimeter Biohorizons Laser-Lok implant was placed, relying on apical fixation only due to insufficient bone volume around the fixture (Figure 4). The autograft taken from the interseptal bone was then placed on the buccal surface of the implant apically, to promote osseointegration and new bone formation (Figure 5). Immediately prior to use, this autograft was soaked in a previously-obtained F3 growth factor rich plasma layer.<sup>1</sup>

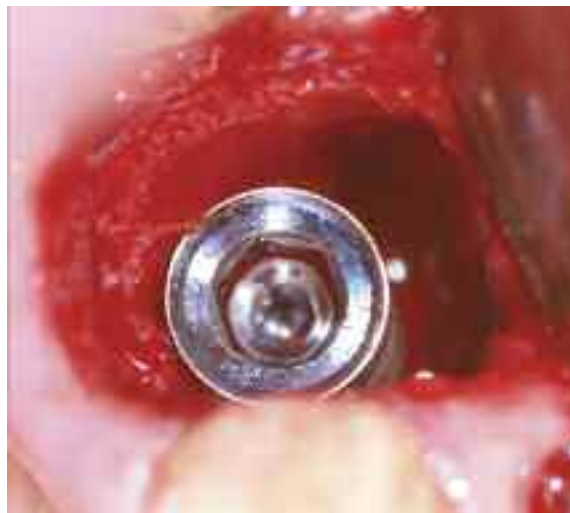
**Figure 4**  
Implant fixture in position. Note insufficient bone volume around mesial, buccal and distal surfaces.

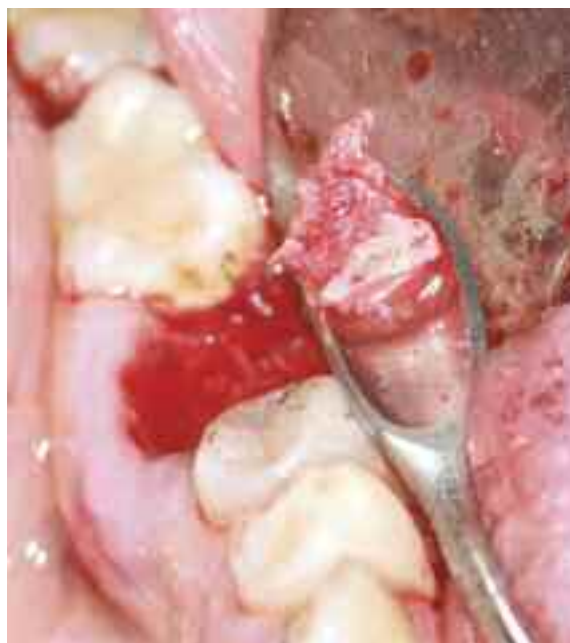
**Figure 5**  
Placement of autograft taken from interseptal bone on the buccal surface of the implant apically.

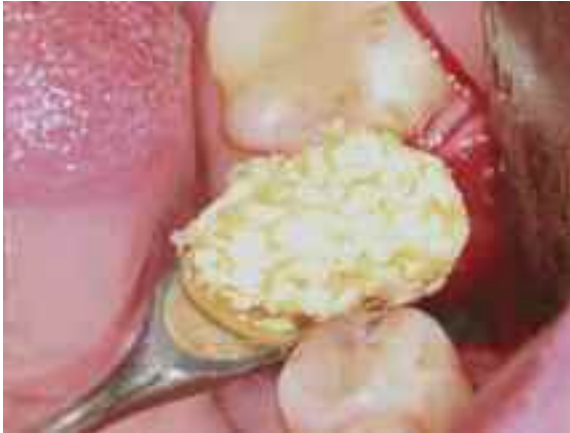
**Figure 6**  
Mineross cortico-cancellous FDBA soaked in F3 growth factors is placed in the bony deficiencies as the first or primary layer.

Next, Mineross (Biohorizons) cortico-cancellous FDBA<sup>2</sup>, also soaked in F3 growth factor, was placed in the bony deficiencies (Figure 6). Bio-oss (Giestlich) was then embedded in the F2 plasma layer and activated with calcium chloride to form a mineralized xenograft “pancake” (xenograft in a biologically-active carrier — Figure 7). Addition of this “pancake” forms the buccal-most layer of the composite graft. This occlusive buccal wall will permit bone regeneration without soft tissue ingrowth.

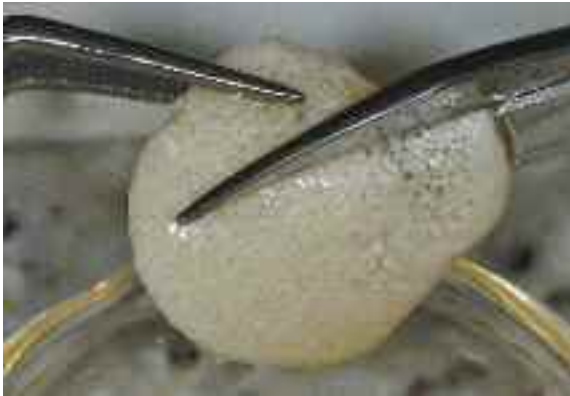
**Figure 7**  
Bio-oss (Giestlich) xenograft "pancake".

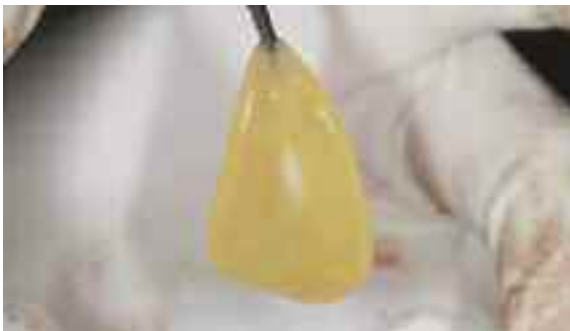
**Figure 8**  
Activated F1 fibrin-rich plasma membrane.

A cover screw was secured to the implant and the activated F1<sup>3</sup> fibrin-rich plasma membrane (Figure 8) was placed over top to completely seal the socket (Figure 9). The tissue was then

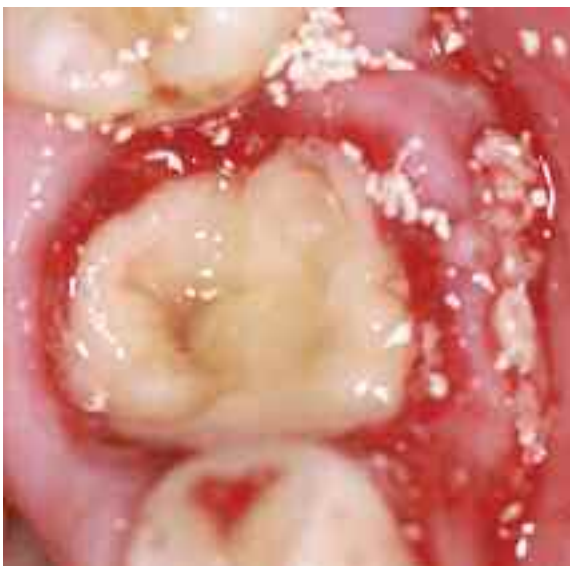
**Figure 9**  
Final position of F1 membrane, showing complete sealing of the socket.

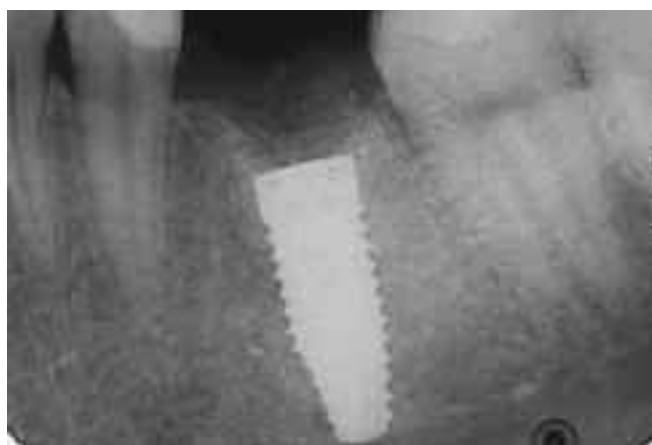
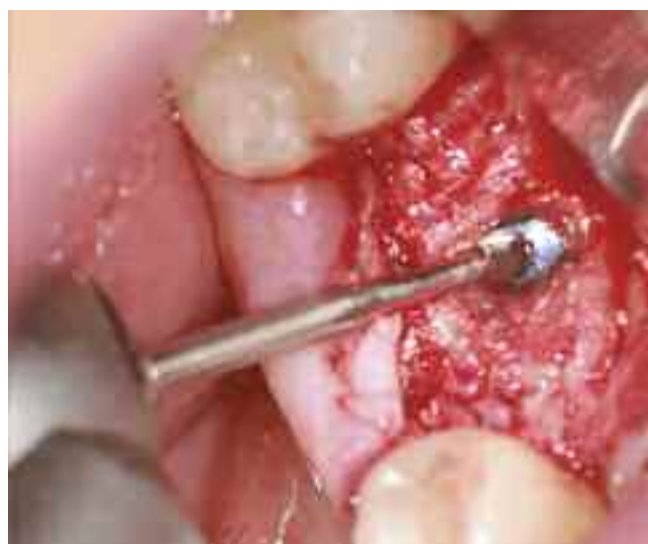
**Figure 10 & 11**

Radiographic and clinical appearance four-months post-operatively, showing implant completely submerged.

Ten days post-operatively, the sutures were removed and excellent soft tissue healing as well as initial epithelial creep over the socket was noted. Four months later, re-entry revealed abundant bone regeneration with complete implant submersion (Figures 10 & 11). Using a No. 4 round bur, osteoplasty to uncover the top of the implant fixture was carried out. A healing abutment was then attached to the fixture and the tissues were re-approximated using 4-0 chromic gut suture (Figure 12).

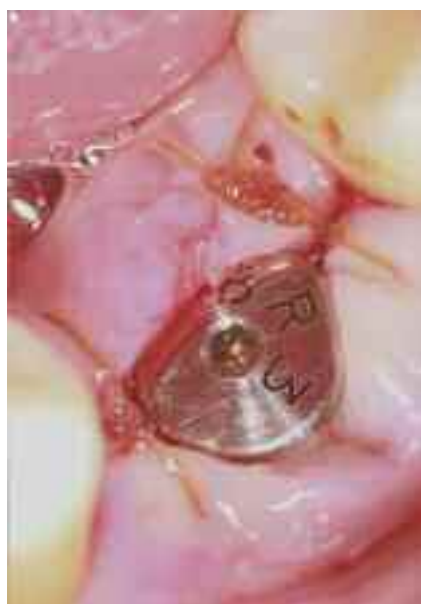
**Figure 12**

Healing abutment in position.

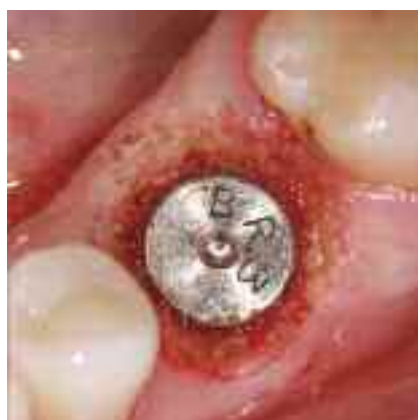
**Figure 13**

Appearance of fixture head following laser gingivectomy.

At the five-month mark, laser gingivectomy was carried out to remove soft tissue overgrowth and to create the ideal gingival cuff for implant crown emergence (Figure 13). Six months post-surgery, the gingival cuff appears healthy and ready to accept the implant crown, so an impression was taken with PVS material and a transfer coping. One week later, the final screw-retained implant crown was inserted (Fig 14). Ideal papilla formation and thick, keratinized gingival tissue was achieved. Composite restorative material was used to fill the occlusal access opening.

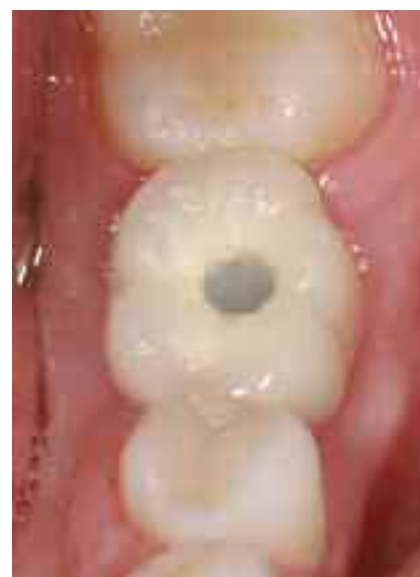
**Figure 14**

At the one-month follow-up appointment, everything appeared stable and the case seemed to be a great success. Unfortunately, the patient did not share this view and was unhappy with the final result. It turned out that the patient was dissatisfied with the occlusal composite plug in the access opening. She objected to the appearance of "a dark spot on my new tooth". In light of this information, the crown was removed and a healing abutment was placed surrounded by a flowable composite, in order to maintain the gingival architecture, while a new cement-retained crown was fabricated (Figure 15).

Screw-retained implant crown with composite resin covering access opening on occlusal surface.

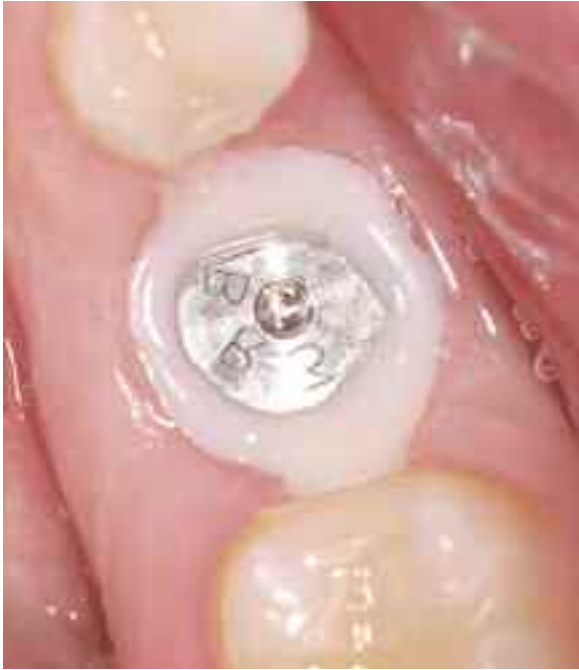
**Figure 15**  
Healing abutment with flowable composite placed to maintain gingival contours.

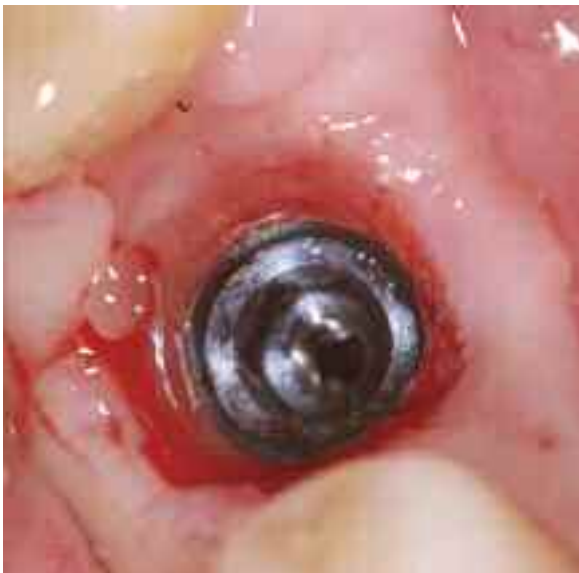
**Figure 16**  
Appearance of gingiva prior to final crown insertion.

removed, revealing a well maintained gingival architecture (Figure 16). The final crown was cement-retained on an adequately torqued abutment. The result was highly cosmetic, with no occlusal access opening, thereby satisfying the patient's esthetic needs (Figures 17 & 18).

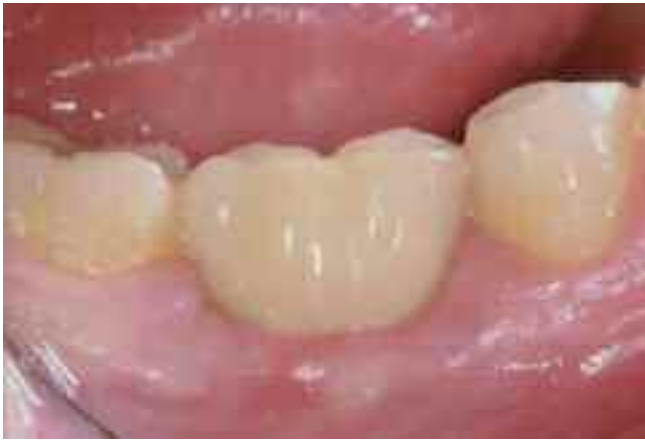
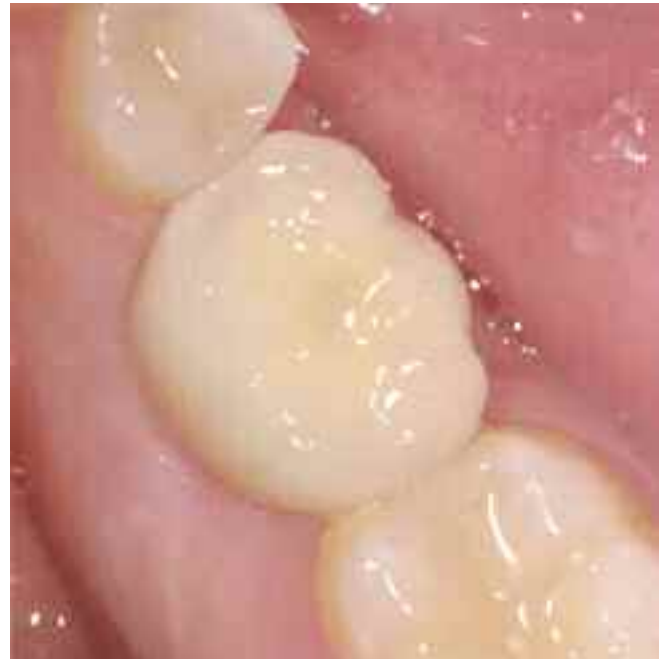
**Figure 17 & 18**  
Clinical appearance of cement-retained crown in position.
